# 2001 COMPANY

## Wind Vented Roof Profile De Soto Missouri Tornado – May 6, 2003

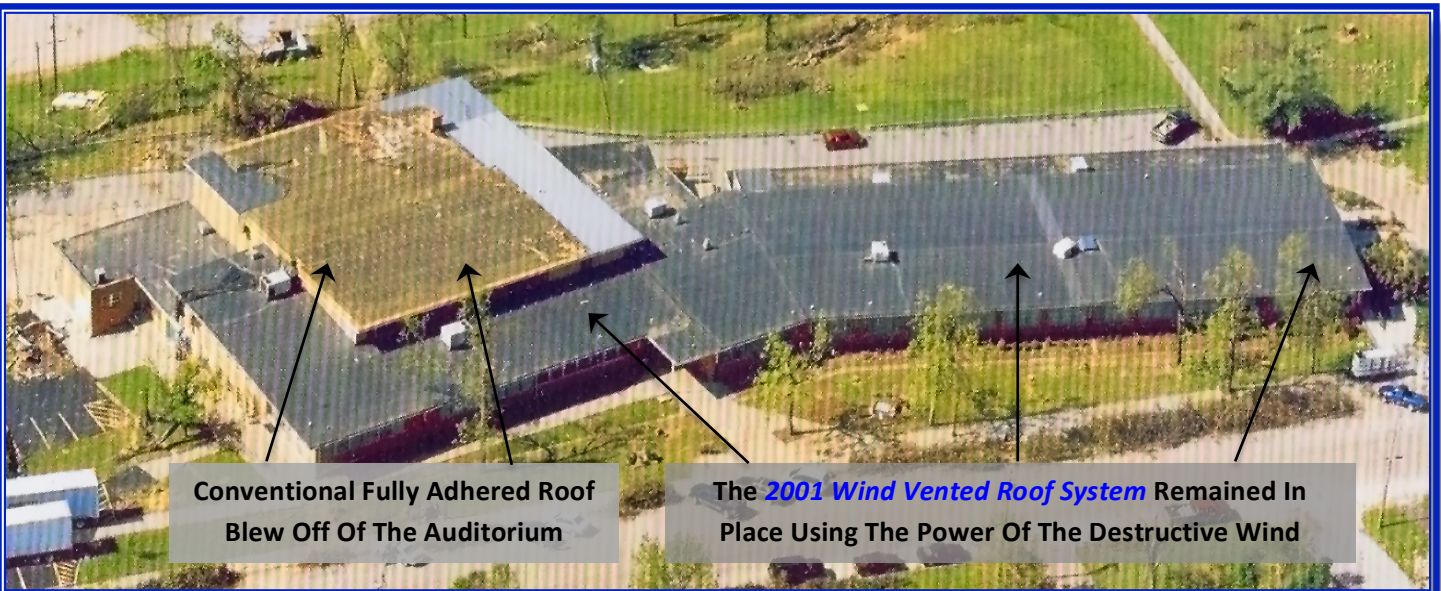
Conventional Fully Adhered Roof  
Blew Off Of The Auditorium

The **2001 Wind Vented Roof System** Remained In Place Using The Power Of The Destructive Wind

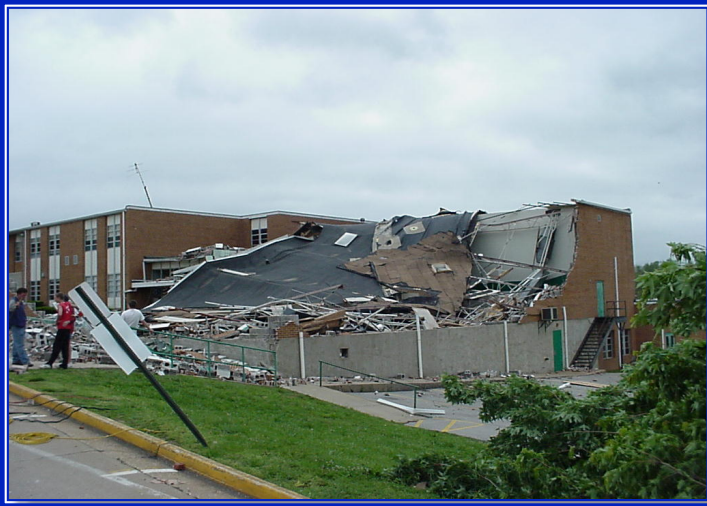
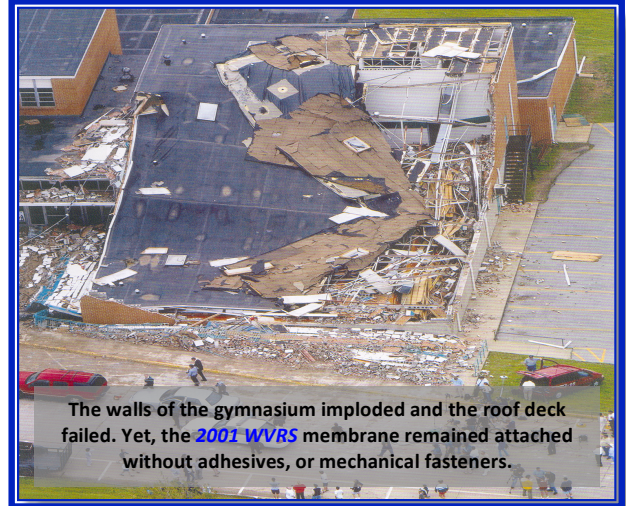
The walls of the gymnasium imploded and the roof deck failed. Yet, the **2001 WVRS** membrane remained attached without adhesives, or mechanical fasteners.

The **2001 WVRS** kept these roofs aerodynamically attached to the deck in the most extreme weather condition possible.

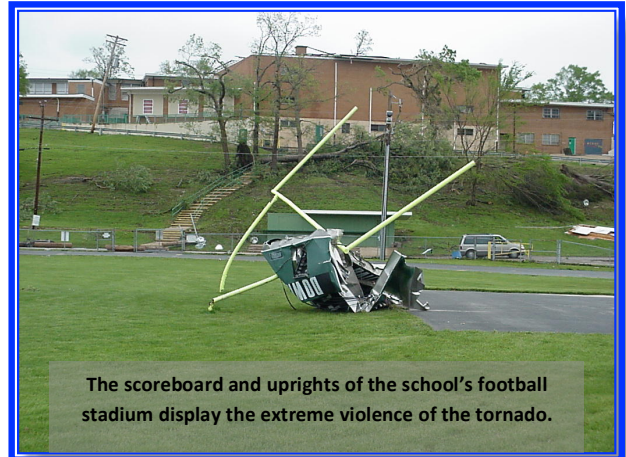
The scoreboard and uprights of the school's football stadium display the extreme violence of the tornado.

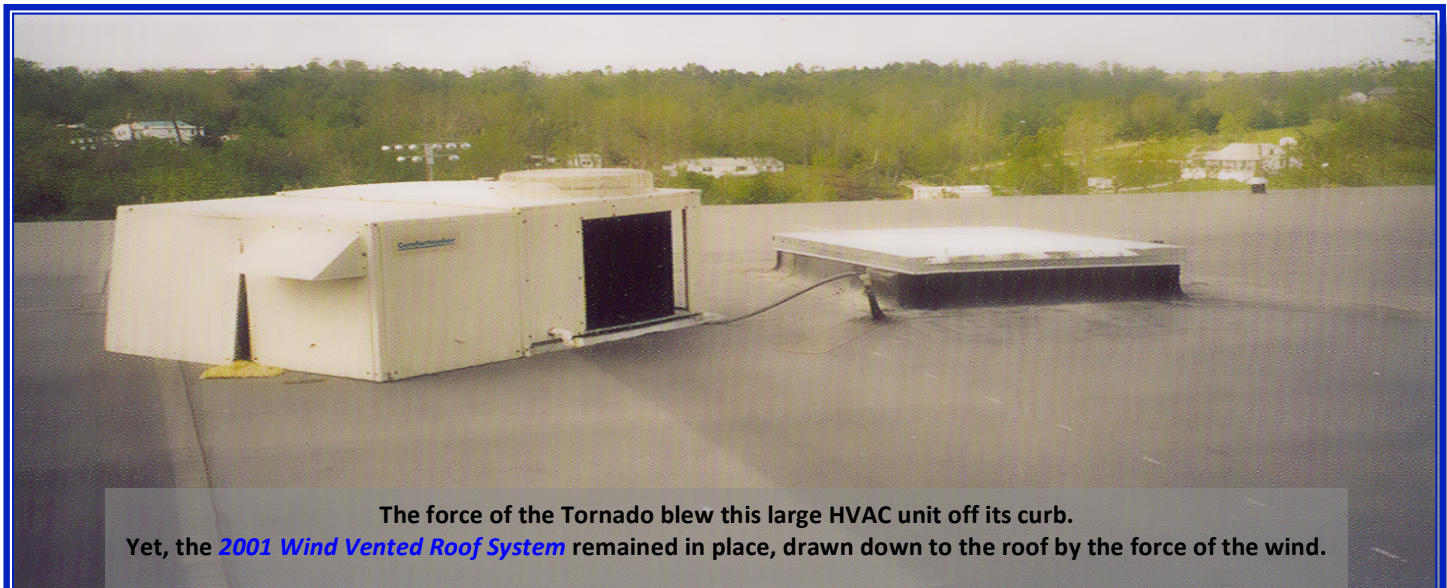
The force of the Tornado blew this large HVAC unit off its curb. Yet, the **2001 Wind Vented Roof System** remained in place, drawn down to the roof by the force of the wind.
