Roofing Contractor

Re: Scheman Building Moisture Survey Results

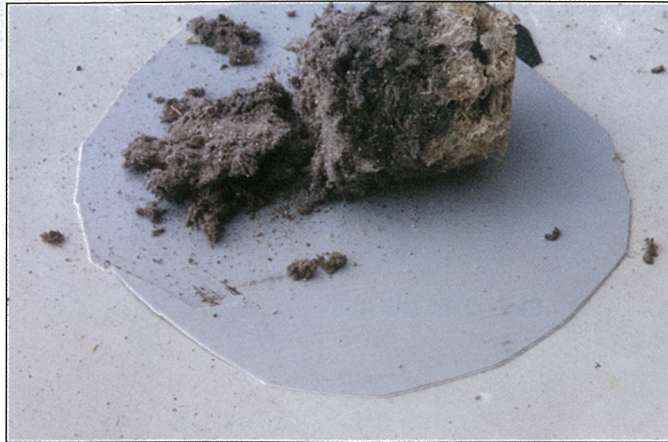
Core cuts show dry insulation.

The insulation consisted of 1.1/2" of perlite and 1/2" wood fiberboard directly below a Hypalon membrane. The vapor barrier appeared to be a modified asphalt membrane consistent with a modified base sheet. Upon observation and as can be seen in the enclosed photographs, the insulation was completely dry.

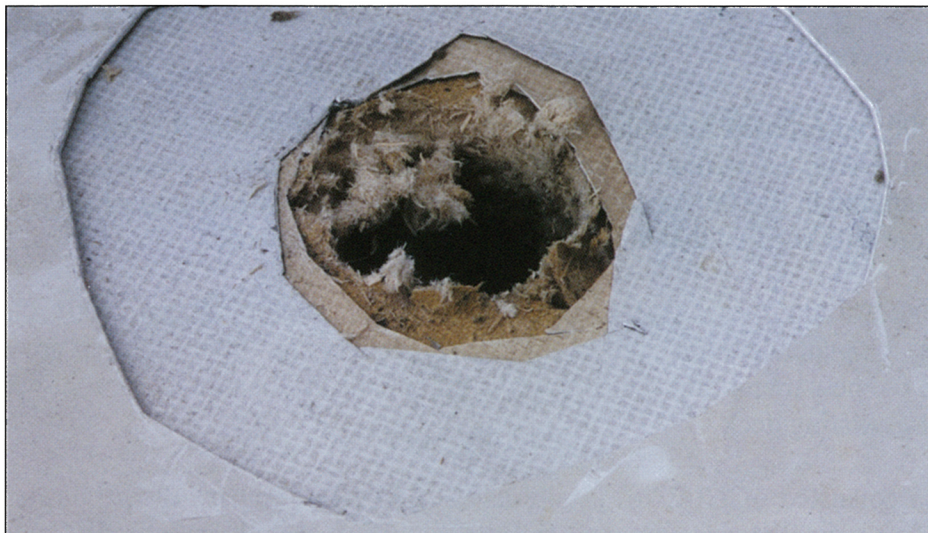
Cuts were made through the new membrane, existing Hypalon membrane and insulation, down to the vapor barrier.

Cuts were made through the new membrane, existing Hypalon membrane and insulation, down to the vapor barrier over the existing deck.
